**RESPONSE OF STREAMFLOW AND SPRING DISCHARGE FROM
PRECIPITATION RECHARGE EVENTS IN ICEHOUSE CANYON
WATERSHED, EASTERN SAN GABRIEL MOUNTAINS, CALIFORNIA**

A Thesis

Geological Sciences

2018

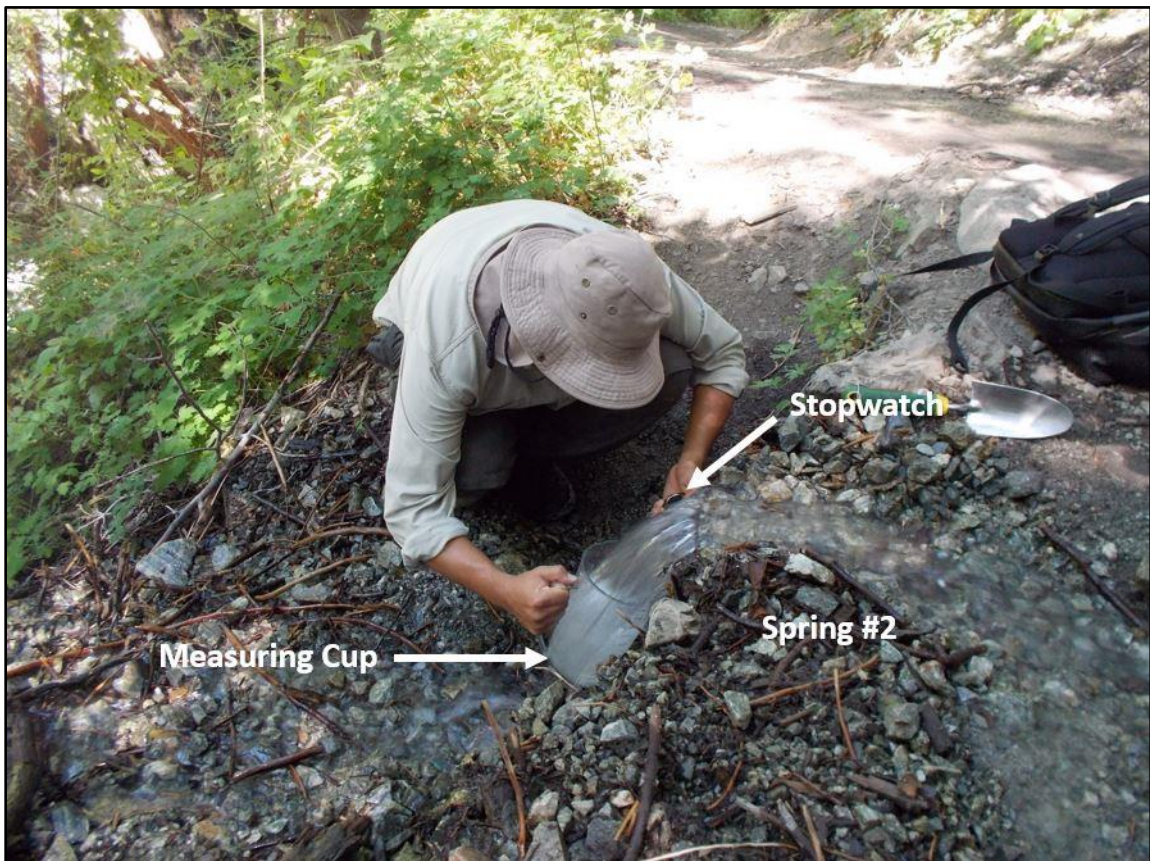
Figure 5. Capturing spring discharge using a measuring cup and stopwatch to record elapsed time.

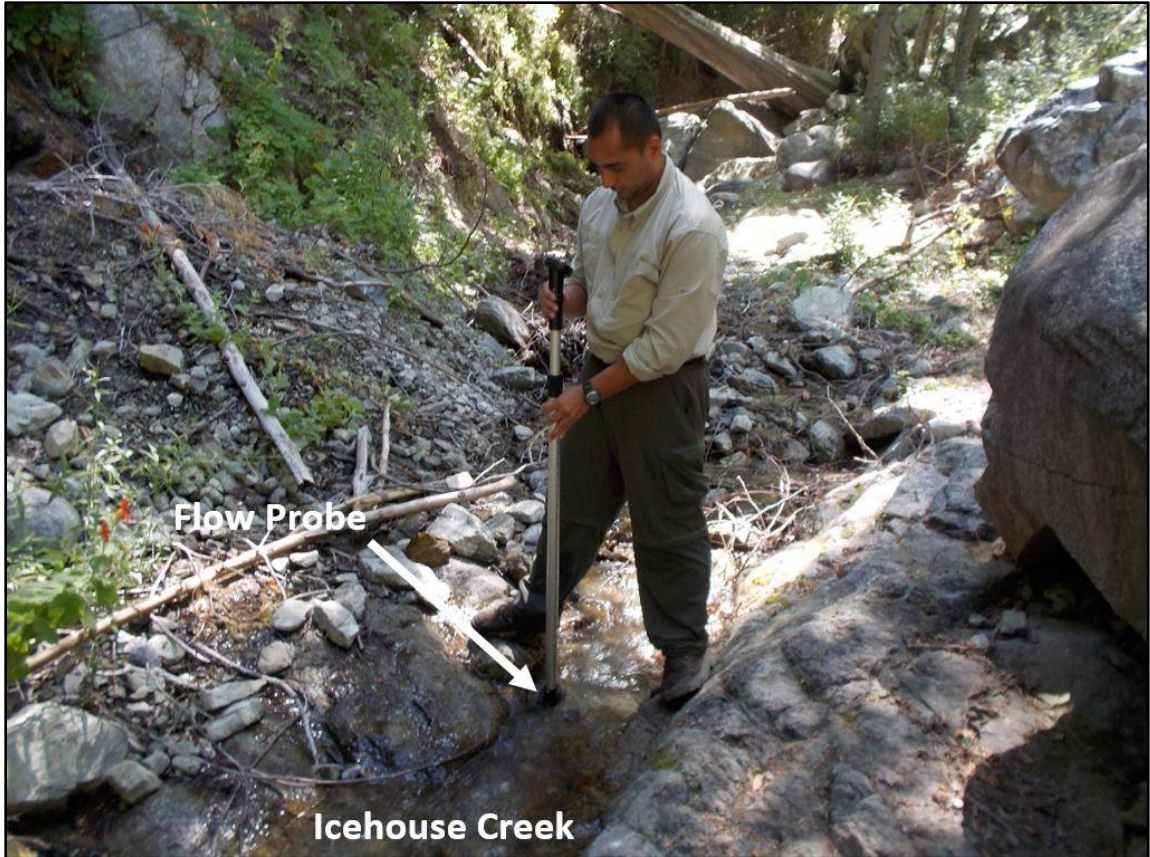
Figure 6. Measuring average stream velocity at the Broullard gauging station using a Global Water digital flow probe.

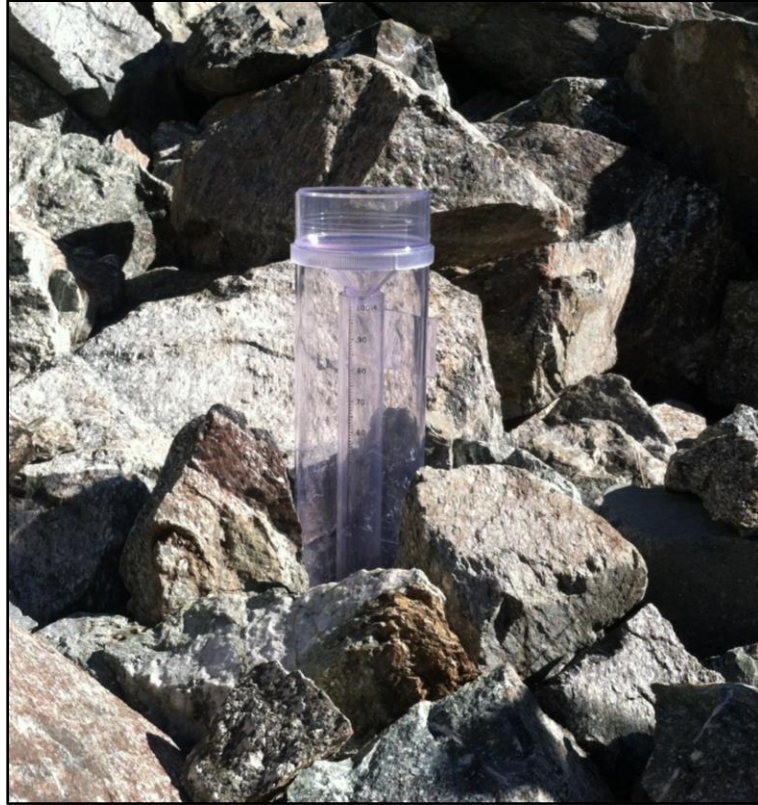
Figure 10. Photograph of an all-weather rain gauge installed at the Cabin 5 location.

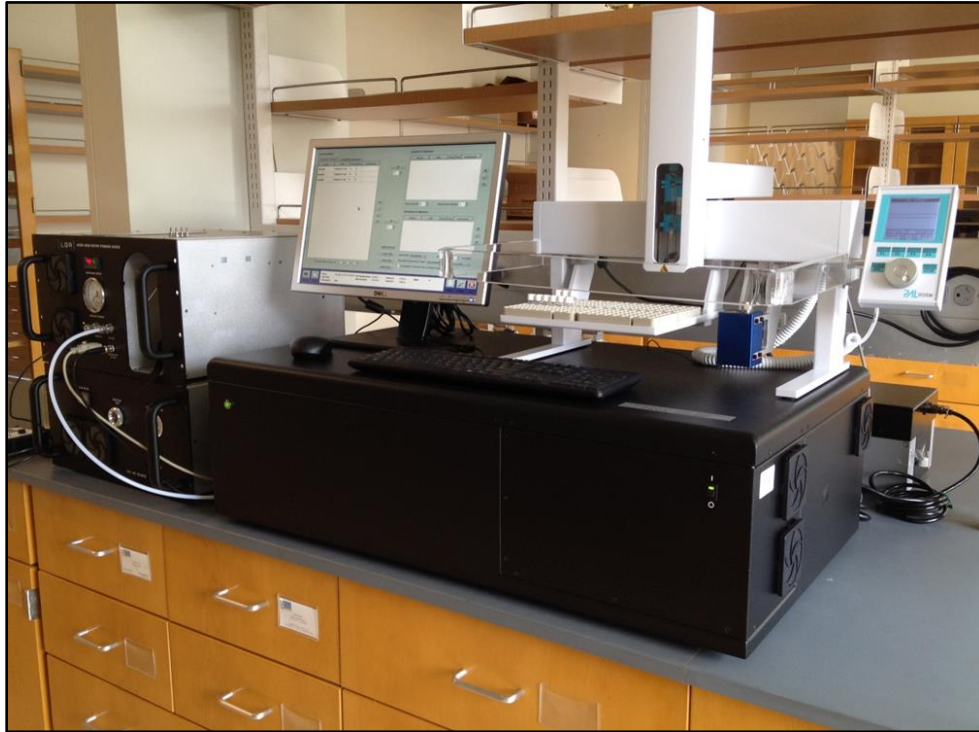
Figure 11. Laboratory equipment used to measure isotopic ratios of stable Hydrogen and Oxygen isotopes located within the Environmental Sciences Department at UC Riverside.

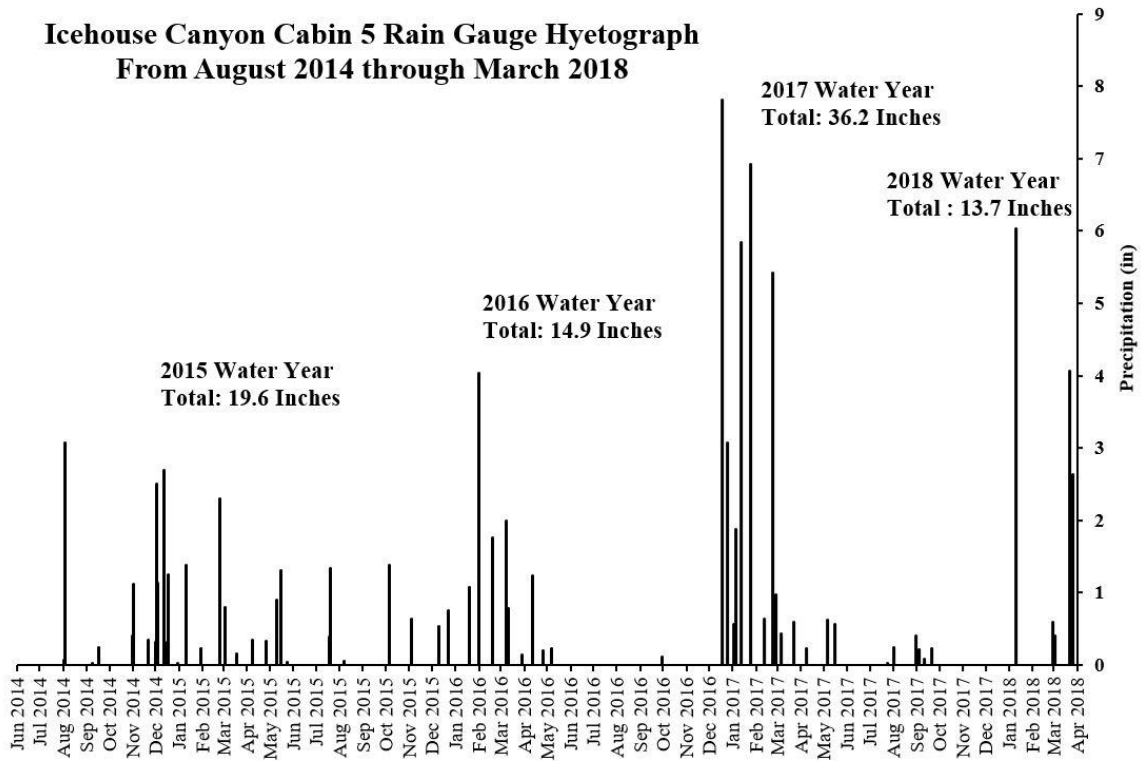
Figure 14. Hyetograph from the Cabin 5 and Sierra Powerhouse rain gauge stations displaying the distribution and magnitude of storm events occurring during the project duration.

where no data was available from the Icehouse Canyon stations. Figure 14 presents a hyetograph showing the distribution and magnitudes of storm events that occurred during the observation period. According to the hyetograph, the distribution and magnitudes of storm events varied from year to year. The storm events ranged from 0 to 7.81 inches of precipitation and averaged 1.34 inches during the data collection phase. The largest storm events were recorded from December 2016 to February 2017. During this time period, the largest storm event generated 7.81 inches of precipitation. This significant storm event was the largest recorded throughout the project duration, and probably provided substantial recharge water to the local aquifers. In addition, a major storm event on January 10, 2018 generated 6.03 inches of precipitation. This was the third largest storm event recorded during the project duration, and is also significant because it is the first major recharge for the watershed since May of 2017.

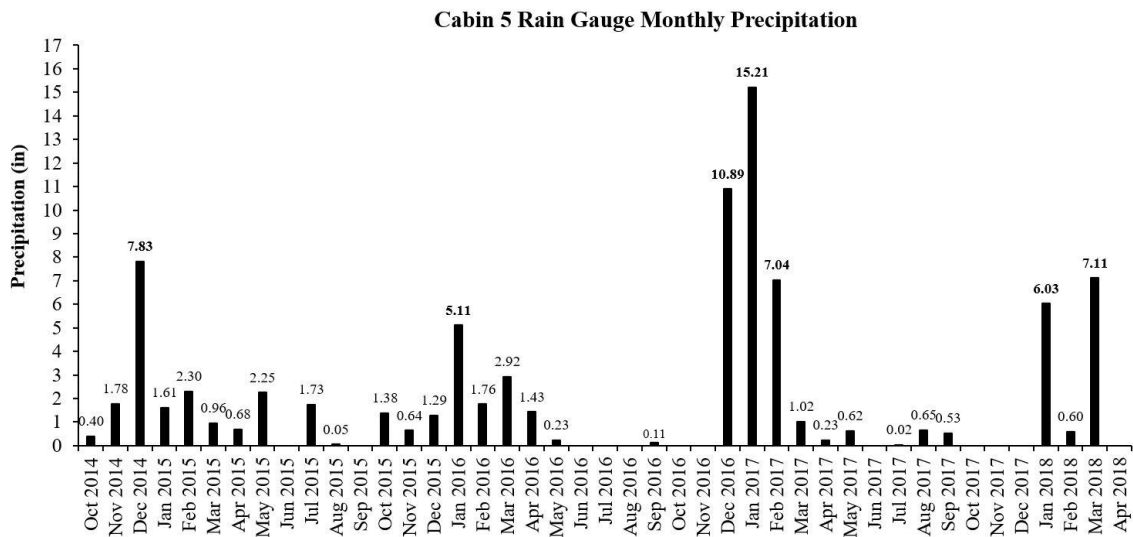
Figure 15. Bar graph displaying the monthly precipitation in units of inches captured with the Cabin 5 rain gauge instrument.

Precipitation data obtained from the Cabin 5 rain gauge was analyzed to determine the amount of monthly precipitation collected. Figure 15 is a bar graph displaying the inches of precipitation that were captured with the rain gauge on a monthly basis over the project duration. The monthly precipitation values were placed above each black bar to clearly show the highest and lowest values. According to the results from this graph, the highest precipitation values were observed during the months of December 2016 (10.9 inches) and January 2017 (15.2 inches). In contrast, the lowest precipitation values were observed during the months of August 2015 (0.05 inches) and July 2017 (0.02 inches). These results show that the precipitation values from the 2016-2017 rainy season are significantly higher in comparison to the previous years. It is possible that the Icehouse

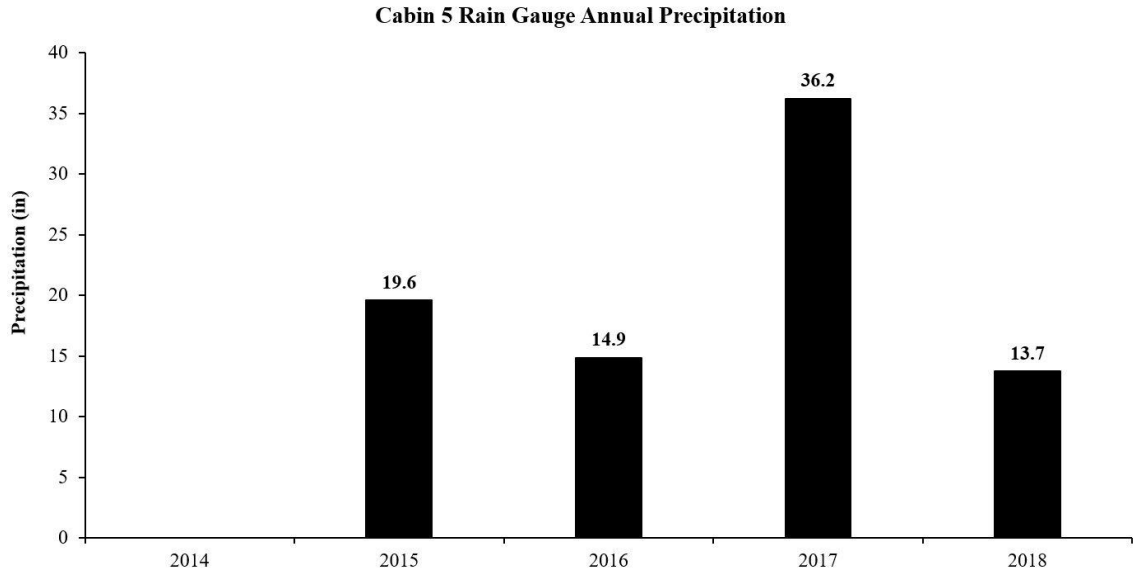
Figure 16. Bar graph showing the annual precipitation in water years for the Cabin 5 all-weather rain gauge until March of 2018.

comparing the annual precipitation beginning in August 2014 and ending in March 2018. In the United States, the term “water year” is defined as a period of 12 months beginning on October 1st of any given year and ending on September 30th of the following year (Fetter, 2001). After careful analysis, the results show that the highest annual precipitation (36.2 inches) occurred in the 2017 water year period. The second highest annual precipitation (19.6 inches) was recorded in the water year of 2015. The high precipitation values observed during the beginning of 2017 strongly suggest that it will surpass the water year of 2016, which should provide substantial recharge water to replenish the Icehouse Canyon watershed aquifers. Furthermore, the least amount of annual precipitation occurred in 2016 during the fifth year of a severe drought in California. This particular year received approximately 21.3 inches less precipitation in comparison to 2017. The annual precipitation for 2018 was not considered as the lowest, because only a few months of data were available for this water year. Moreover, the significant amount of precipitation that the watershed received in the wet season of 2017 contributed to improved conditions and may have even resulted in the full recovery of the watershed from the effects of a historical drought period.

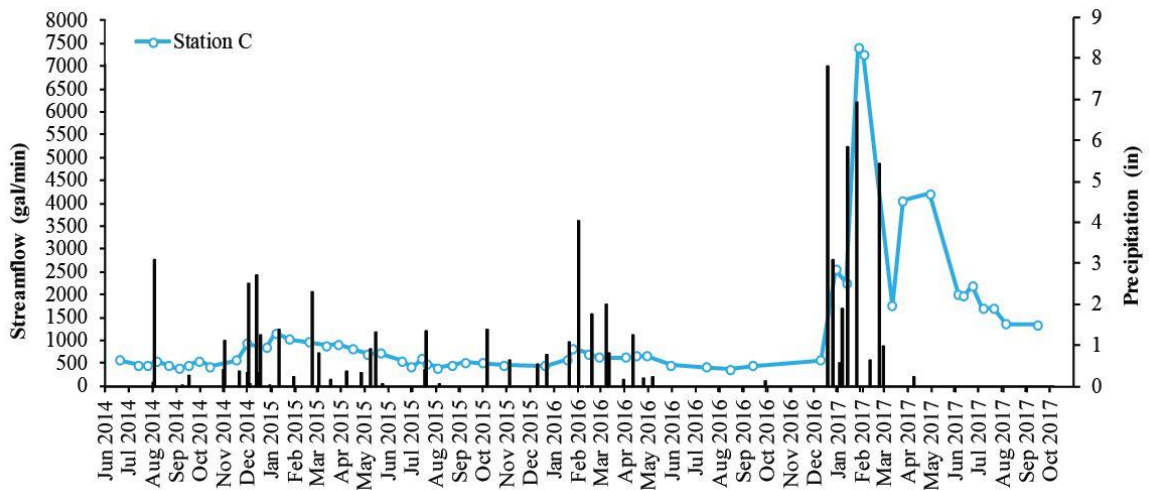
Figure 20. Runoff hydrograph overlaid by a precipitation hyetograph for gauging station C.

These responses consist of various magnitudes including minor, intermediate, and major. The highest response of 7,391 gal/min occurred on February 15, 2017 following a minor storm event that produced 0.64 inches of precipitation. As a result, the streamflow at this particular station experienced an increase of 229% from the previous observation. A second significant response of 1,803 gal/min occurred on January 13, 2018 from a storm that generated 6.03 inches of rainfall. This response resulted after several consecutive months of little to no precipitation recharge in the canyon. In addition, the summer storm from August 3 of 2014 triggered a minor response that increased the streamflow by 24%. This is a significant difference in comparison to the responses recorded at Stations A and B from the same storm event. Furthermore, it is also important to note that most of the major hydraulic responses occurred during the rainy season of 2017, when historical storm events were observed.

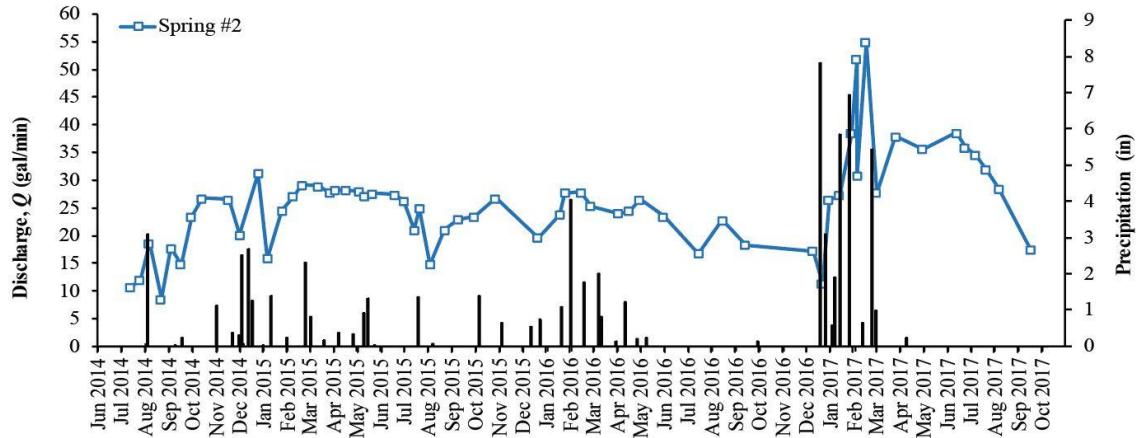
Figure 25. Spring #2 hydrograph displaying discharge over time overlaid by the main precipitation hyetograph.

The results from the Spring #2 hydrograph reveal a more complicated responsiveness to precipitation recharge events. During the project duration, three major (>60% increase) hydraulic responses were observed. The first major response occurred on September 5, 2014 without the occurrence of any storm events during this time. Spring discharge for this response was determined to be 18 gal/min, which represents a 108% increase from the previous value. Additionally, another major response occurred on January 16, 2017 after the occurrence of a significant recharge event that produced 5.84 inches of precipitation. The spring discharge increased to 26 gal/min, which was one of the greatest percent increases (132%) recorded during the data collection period. A third major hydraulic response was observed on March 6, 2017 following a small storm event of 0.43 inches of rainfall. This resulted in a 78% increase in spring discharge. Moreover, the observance of multiple hydraulic responses may indicate that this particular spring is more sensitive to precipitation recharge events. With regards to water resources, the results suggest that availability of spring water will increase soon after a storm event

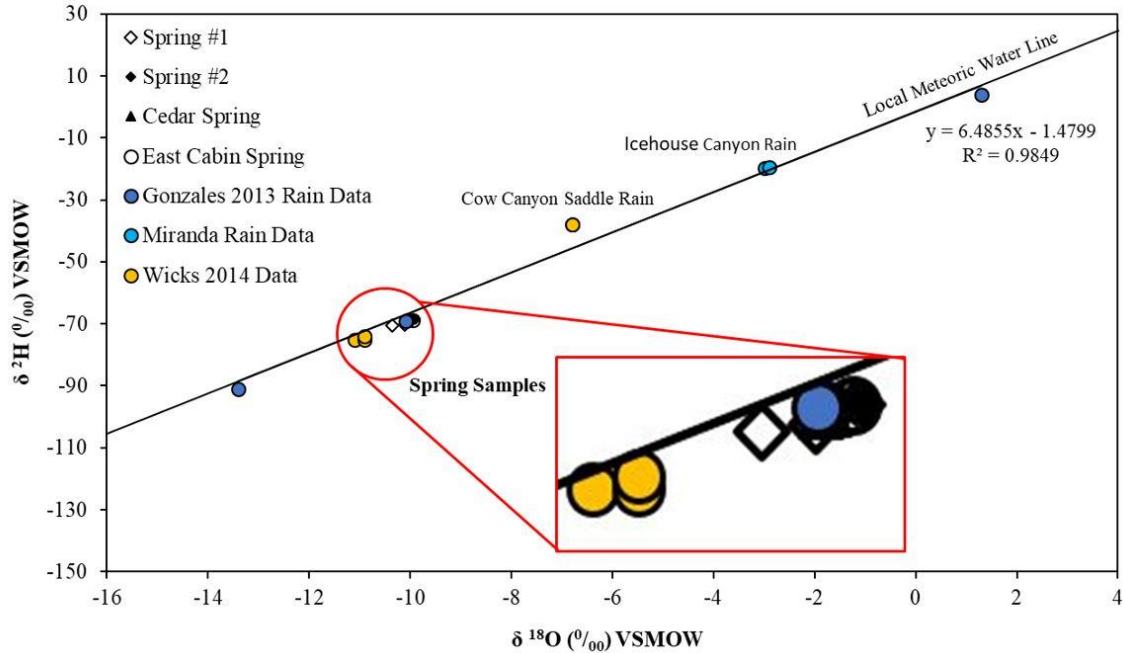
Figure 29. Plot of deuterium versus Oxygen 18 for precipitation and spring samples collected in Icehouse Canyon. Data sources from Gonzales 2013 and Wicks 2014 thesis reports.

The results from the spring samples were plotted along with the precipitation samples to examine any similarities or differences. Figure 29 presents a plot of Deuterium versus Oxygen 18 showing the similarities in isotopic signature between the different types of water samples. The isotopic results reveal significant similarity between the spring samples and the precipitation samples. For example, the four spring samples plotted nearly on the local meteoric water line (LMWL) represented by the solid black line. To determine the LMWL, a total of six precipitation samples were used from different research studies. Two of the samples were collected from Icehouse Canyon for this study, one sample from Cow Canyon Saddle by Logan Wicks in 2014, and three samples from Thomson Creek by Jazmin Gonzales in 2013. The LMWL indicates the specific areas on the graph where precipitation water is expected to plot for that particular region. According to the graph, all the spring samples collected from Icehouse Canyon appear to plot within a narrow range of $\delta^{18}\text{O}$ and $\delta^2\text{H}$ (deuterium) values, which also tend to fall close in proximity to the local meteoric water line. Similarly, the spring samples from Wick's study represented by gold circles also plot close to the meteoric water line.

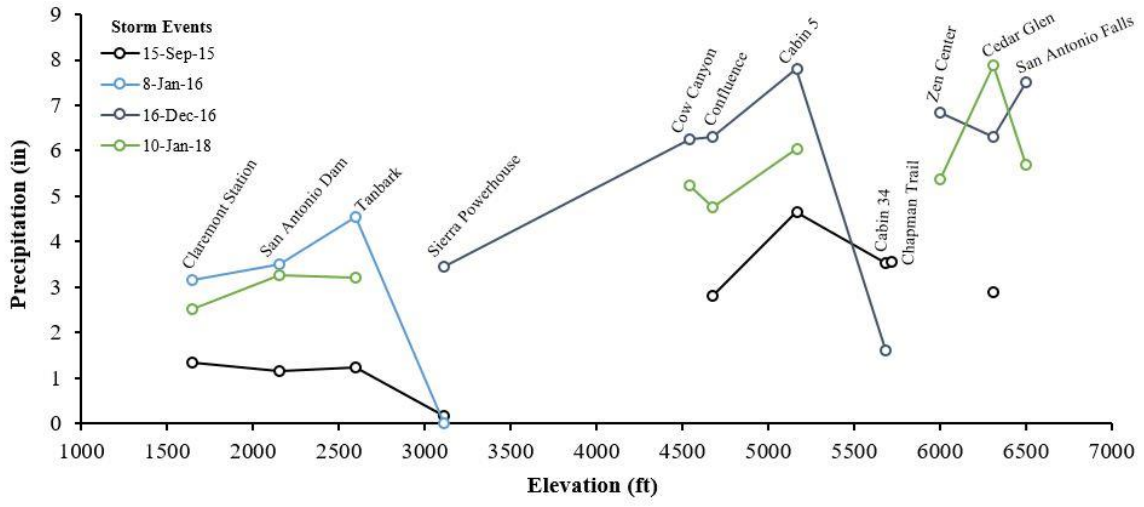
Figure 35. Graph comparing precipitation and elevation data for twelve rain gauges to examine a potential orographic effect for larger storm events.

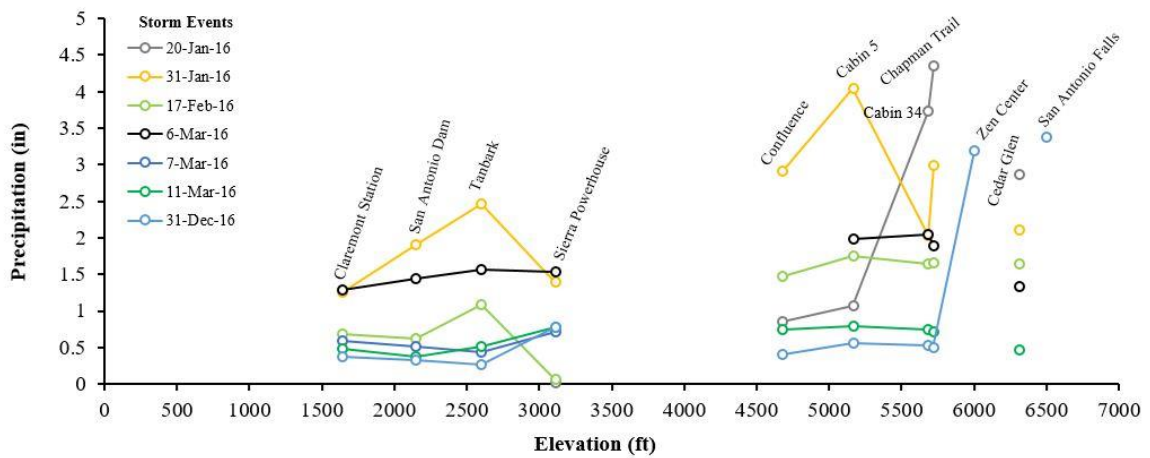
Figure 36. Graph comparing precipitation data and elevation for twelve rain gauges to determine orographic effects for smaller storm events.
